PAVILION V

PROBLEMS OF REPAIR

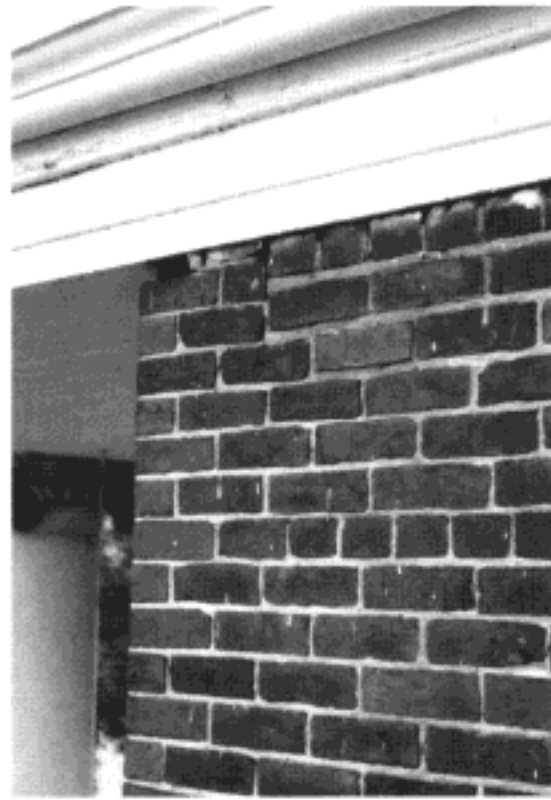
Improper pointing and open mortar joints at the east end of the north elevation

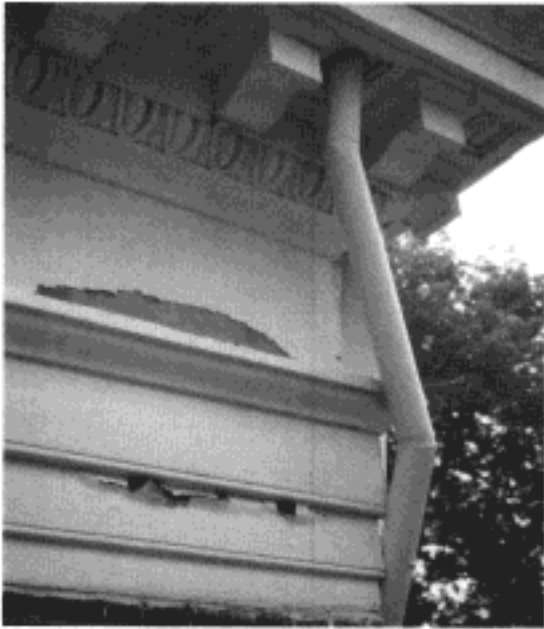
Crazed and peeling paint at the southwest corner of the original entablature

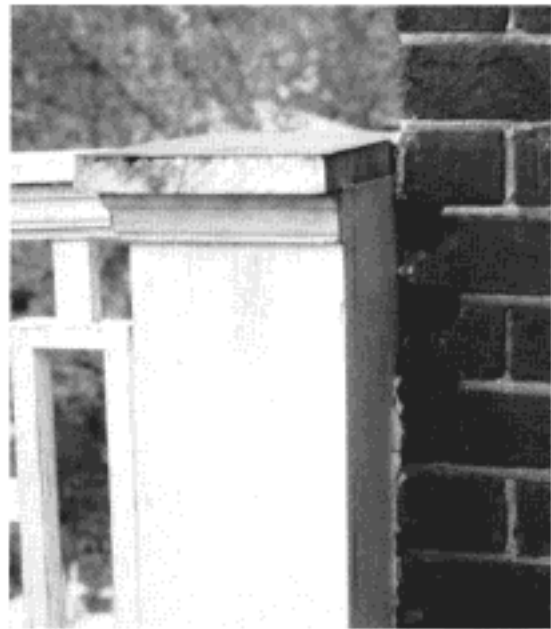
Broken brick at the west end of the south roof terrace

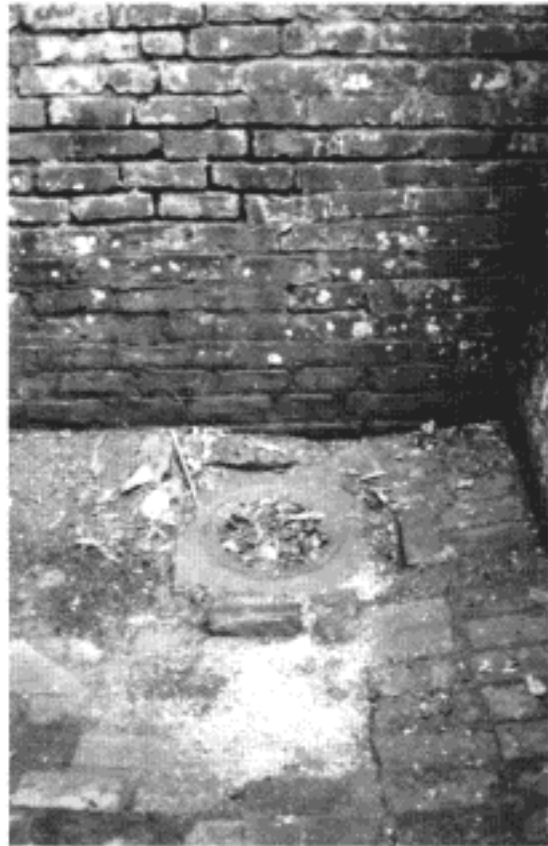
Deteriorated mortar and inadequate drainage conditions in the areaway at the northwest corner of the original building
