Basement Restoration Plan

RESTORATION AND RENOVATION

PAVILION VII

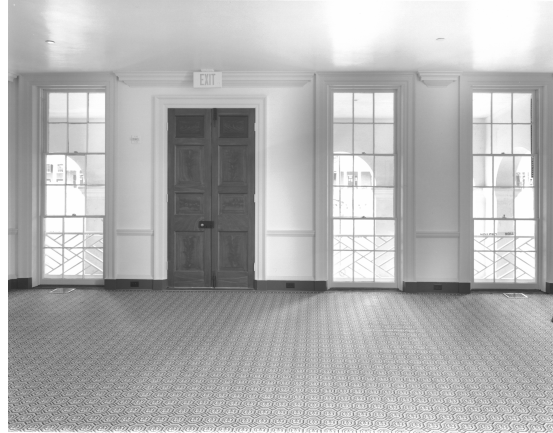
East wall of Room 102

Investigation: The original double-door entrance (Door 1022), long hidden beneath wood lath and plaster, is being opened from the interior. Masonry walls flanking the fireplace in the west wall are being examined and documented and then resealed, using metal lath and plaster. The latter shows that two openings, probably windows, were made after the wall had been built, though subsequently closed. Thus they are not being recreated, since not original.

Restoration: The six-foot wide opening at the center of the north wall is being altered as described above. The east wall entrance is being recreated. The entrance consisted of a double door, each with four panels. The pine doors grained as “mahogany” had been covered with wood lath and plaster on the interior and required cleaning with a mild soap and water. The doors are being re-grained as “mahogany” thus encapsulating the early finishes. New door trim and hardware are being installed to recreate original conditions. New exterior steps are being constructed at this entrance. Carpet representative of the period (selected from the archives of Woodward Grosvenor in England) is being installed

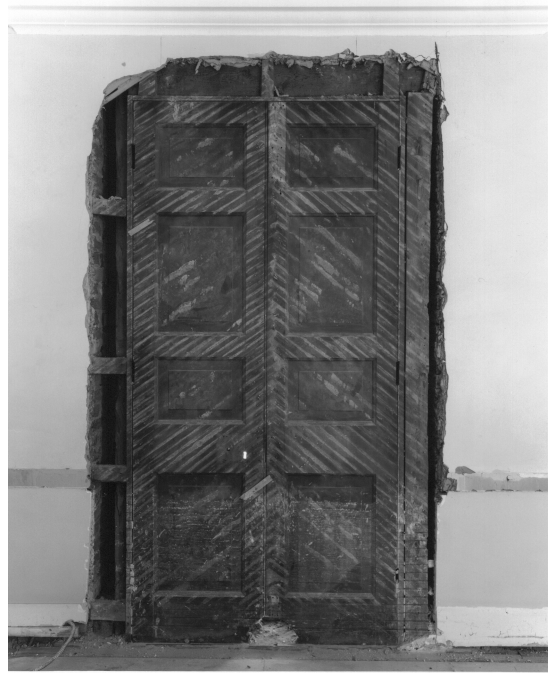
Original entry door to Room 102 during excavation work

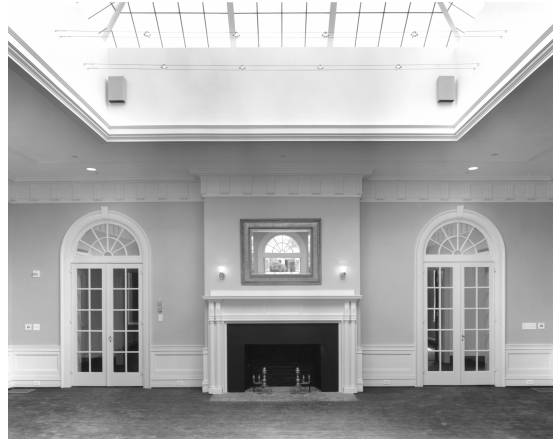
East wall and fireplace in Room 113 with the recreated skylight above

Restoration: Based on the 1913 plans, a new skylight is being engineered, eliminating problems of leakage, thermal loss/gain, and ultraviolet radiation pertaining to the original design. Size and location are clear from the extant steel support structure, which is being retained as a foundation for the new skylight. The new skylight consists of a composite panel of fiberglass-reinforced translucent faces bonded to a grid of interlocked aluminum I-sections. The design of the original skylight displayed an almost flat hipped roof surmounted by a small vent. The new system employs a hipped roof with a steeper slope, without the vent. In addition, Door 1134 is being re-opened and a projection screen is being mounted above the ceiling near the south wall.
