Basement Restoration Plan

RESTORATION AND RENOVATION

PAVILION VII

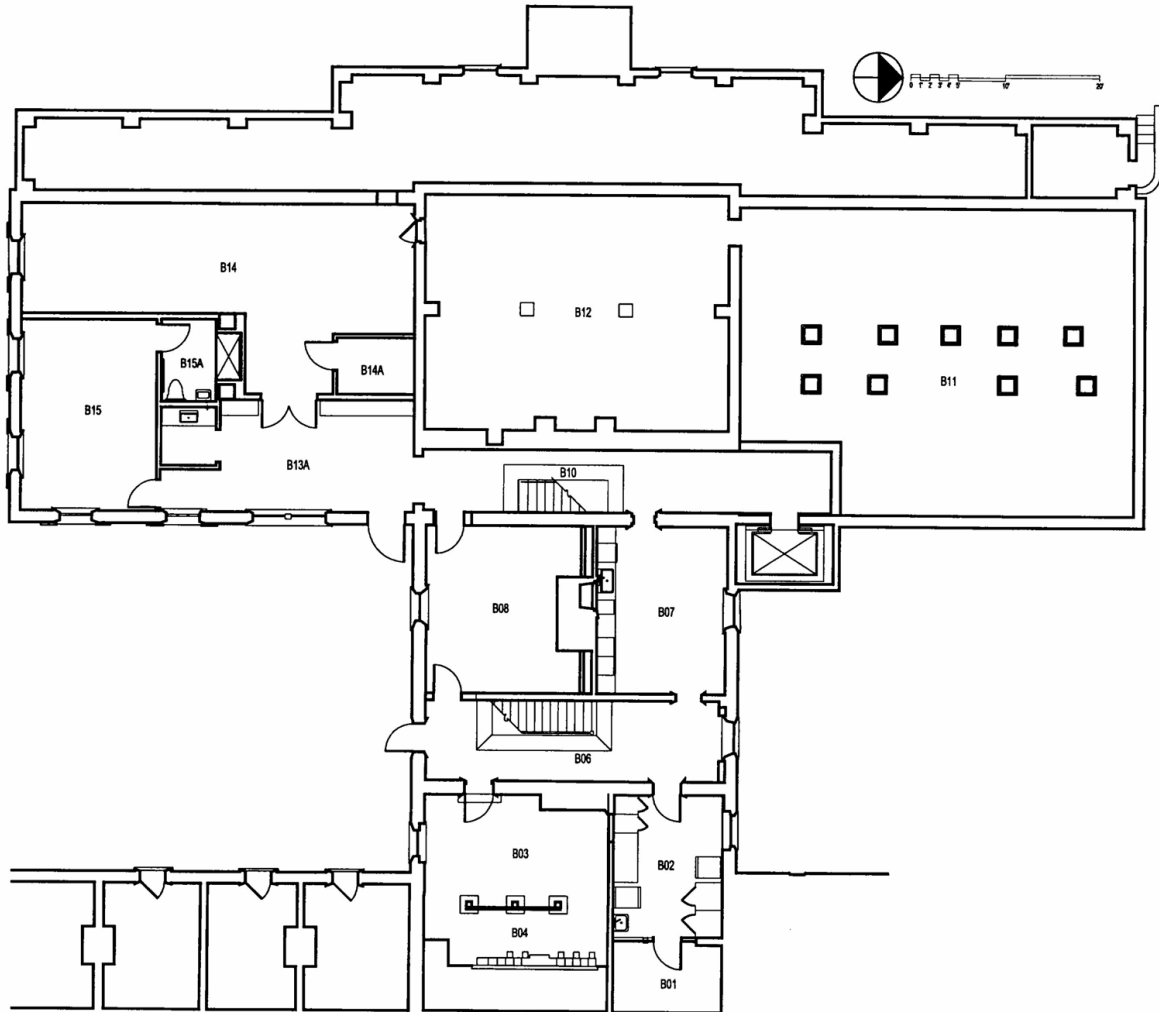
Investigation: The wall surface between B01 and B02 is being removed to expose the wall structure. Door B011 is being removed. The ceiling is being removed for examination of the structure above. Piping on the east wall is being reconfigured. Electrical conduit to adjacent buildings is not being changed.

Restoration: A new wall is being constructed as continuation of the existing masonry spur wall, thus reducing room size. The concrete floor is being extracted to achieve a uniform floor level from B06. Evidence of brick as previous flooring material is being found beneath the concrete.

Investigation: A 3' X 3' square is being cut into the con-

crete floor to allow for archaeological evaluation of conditions. Evidence of brick as a previous flooring material is being found. The concrete floor is then being extracted to achieve a uniform floor level with B06. The single-sided stud wall between B01 and B02 and door B011 are being removed. Door B022 and the doorframe into B03 are being removed.

Restoration: The door opening into B03 is being closed using brick and plaster. Room size is being increased with the relocation of the wall of B01. A new drywall ceiling is being installed. The window vent is being replaced by glass. A hole in the west side of the window casing is being closed. The board-and-batten door between B02 and B06 (B021) is being rebuilt, swinging inward to B02. New casework, a washer and dryer, a service sink, and a countertop sink are being installed along the south wall.

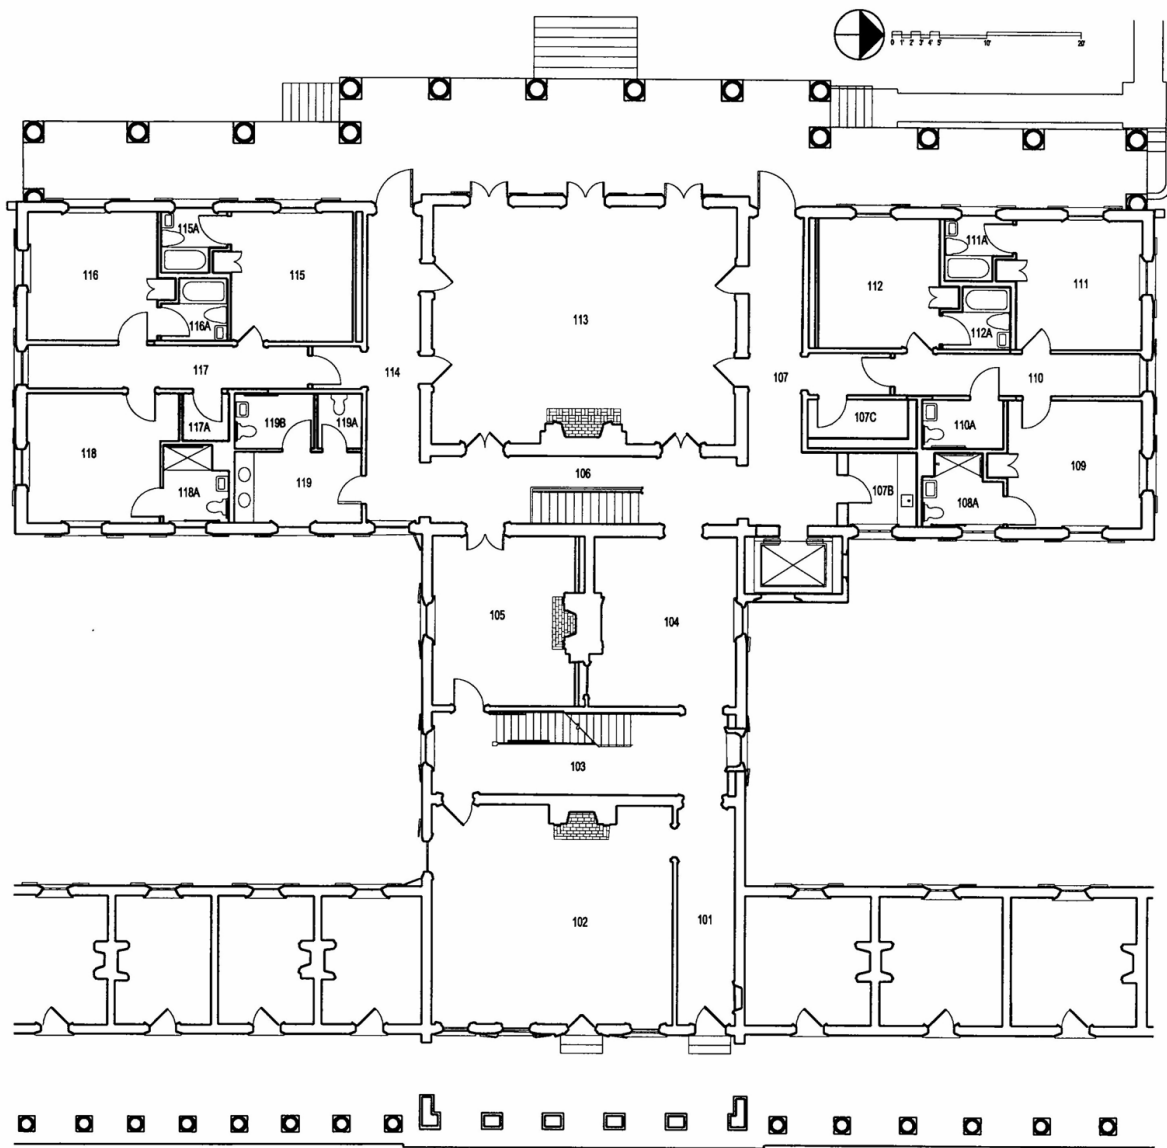
First Floor Restoration Plan

Investigation: The north wall and ceiling cavity are being partially dismantled to determine the location and size of the original stairway. Floorboard cuts, irregularities in cornice and baseboard, and hairline cracks in plaster hinted at its placement. Paint and plaster removed from portions of the north wall reveal the orientation of the stair to the second floor, rising from west to east. The original ceiling puncture had been closed with an insert of wood framing members. Following documentation of previous conditions, the ceiling and wall are being closed using metal lath and plaster and the chair rail is being repaired. The width of the stair was roughly half the width of the hall. Investigation suggested that the stair had an open balustrade rising to the second floor level, where it opened into the large room above, flanked by the same open balustrade. From the first floor, to the floor below, the stair was probably enclosed by wood paneling similar to that in Pavilion V. Cork-board and mailboxes are being removed from the door to the adjoining student room. The door remains sealed and will serve to document an early change effected to increase living and working space in Pavilion VII.

Restoration: The six-foot wide opening at the center of the north wall is being altered as described above. The east wall entrance is being recreated. The entrance consisted of a double door, each with four panels. The pine doors grained as “mahogany” had been covered with wood lath and plaster on the interior and required cleaning with a mild soap and water. The doors are being re-grained as “mahogany” thus encapsulating the early finishes. New door trim and hardware are being installed to recreate original conditions. New exterior steps are being constructed at this entrance. Carpet representative of the period (selected from the archives of Woodward Grosvenor in England) is being installed
